# Manhole Inspection Summary

Manhole # S45MM\_021MH

Insp Date: **3/25/08 3:18 PM**

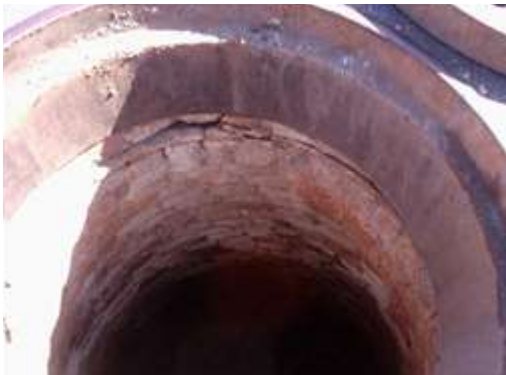
Defect 2

**Frame** Offset: **0.5** (in.) Condition: ☐ Sound ☐ Cracked ☒ **Leaks**

Frame Leaks

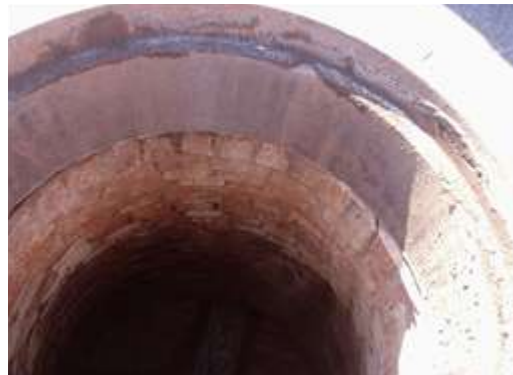
Defect 1

Condition: ☐ Sound ☐ Cracked ☐ Root Intrusion ☒ **Loose Brick** ☐ Deteriorated

Infiltration: ☐ None ☐ Joint ☐ Cracks ☒ **Mortar** ☐ Roots ☒ **Wall**

Adjustment Joint

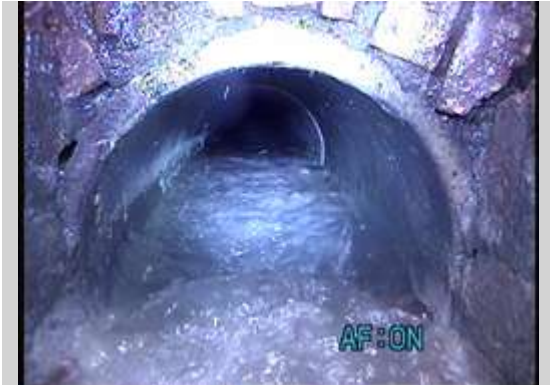
12 O'Clock Outflow

10 in. Circular Gravity Sewer  
Pipe Out @ 12 O'Clock

Pipe Height: **10.8** (in.) Rod and Bar (Angled)  
Pipe Material: **Clay** ☐ Pipe Lined  
Invert Depth: **9.20** (ft.) Flow Characteristics: **Fast**  
Deposits: ☒ None ☐ Mud ☐ Sludge ☐ Debris ☐ Grease  
Silt Depth: (in.) Deposits Extent:  
Infiltration: **None** Pipe Seal Cond: **Sound**

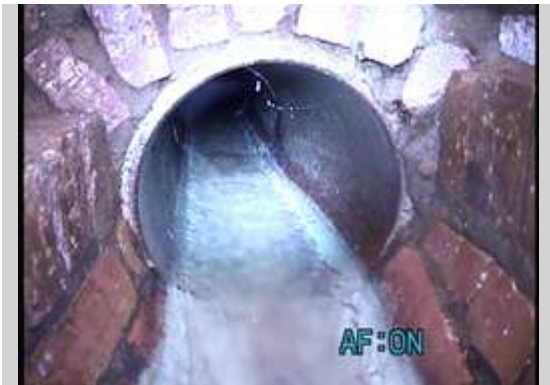
3 O'Clock Inflow

10 in. Circular Gravity Sewer  
Pipe In @ 3 O'Clock

Pipe Height: **10.8** (in.) Rod and Bar (Angled)  
Pipe Material: **Clay** ☐ Pipe Lined  
Invert Depth: **8.70** (ft.) Flow Characteristics: **Fast**  
Deposits: ☒ None ☐ Mud ☐ Sludge ☐ Debris ☐ Grease  
Silt Depth: (in.) Deposits Extent:  
Infiltration: **None** Pipe Seal Cond: **Sound**
